RESEARCH ARTICLE

IMPACT OF LANDFILLS ON GROUNDWATER QUALITY USING HYDROCHEMICAL AND ELECTRICAL RESISTIVITY METHODS AT APETE/AWOTAN AREA, IBADAN, SOUTHWESTERN NIGERIA

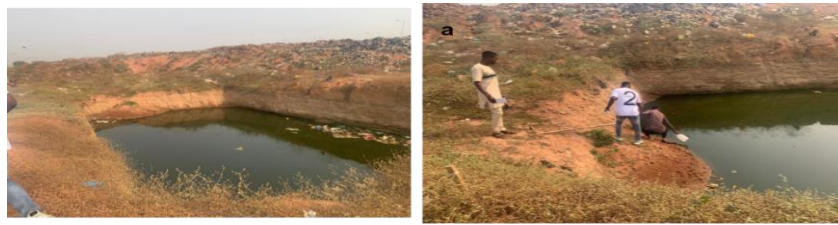
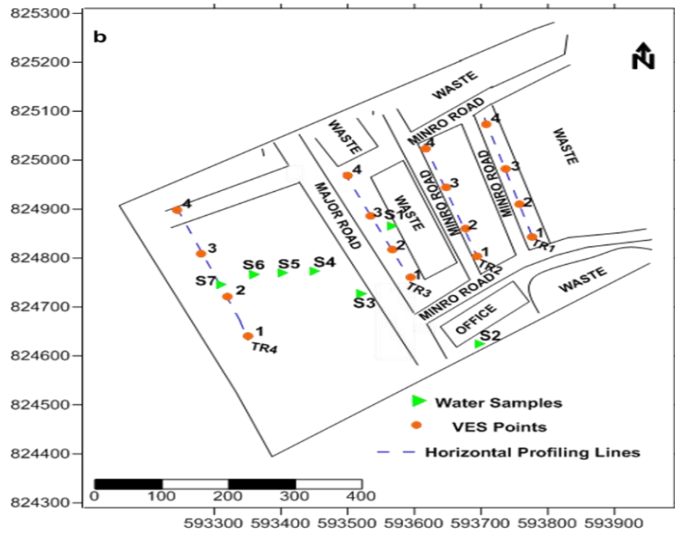
Figure 3: (a) Leachates control point (b) Data acquisition map of the study area

Four traverses were generated approximately W-E direction within and outside the landfill with the fourth traverse which serve as control (Figure 3b). The resistivity terrameter used was Pasi resistivity meter with the associated source of power (Battery) which allows for the readout of

4.9 General Observation on the Leachate Control

The leachate control points were not properly maintained. From the borehole data within and at 20 m away from the landfill; it was observed that subsurface lithological properties have high porosity and permeability (Figure 12). The upper 3 m are lateritic and between 3 to 10 m are sandy clay and sand formation, which allow the easy migration of the contaminant laterally and vertically. A proper measure should be taken to prevent further movement or migration of the contaminant since the near-surface lithologies parameters are sandy in nature with high permeability.

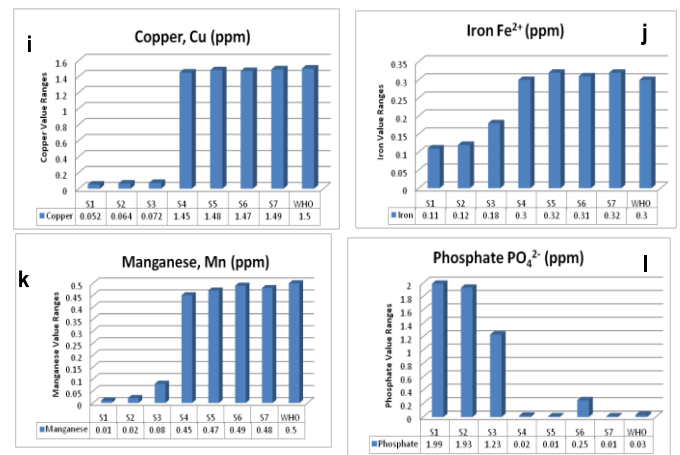
Manganese are an indication of leachate saturation and hence confirm the leachate pollution within the area. However, S4, S5, S6, and S7 fall within the recommended WHO safe value for drinking water. At a concentration greater than the WHO recommended standard, manganese may cause a noticeable colour, odour, or taste in water. However, potential health effects from manganese are not a concern until concentrations are approximately six (6) times higher.

Figure 8l exhibits the phosphate concentration of groundwater with values ranging from 0.01 – 1.99 ppm with an average value of 0.78 ppm. The values obtained at S1, S2, and S3 are generally more than the WHO recommended safe values of 0.03 ppm of drinking water. Relatively higher phosphate concentration obtained from S1, S2, and S3 is an indication of groundwater pollution when compared to S4, S5, S6, and S7 which fall within the recommended WHO standard value for drinking water. Too much phosphorus can cause increased growth of algae and large aquatic plants which can result in decreased levels of dissolved oxygen a process called eutrophication. A high level of phosphorus can also lead to an algae bloom that produces algal toxins which can be harmful to humans and animals.

Figure 8i displays the copper concentration of groundwater with values ranging from 0.051 to 1.49 ppm with average values of 0.87 ppm. The values within S1, S2, and S3 generally fall below the WHO recommended safe value for drinking water. The lower concentrations of copper are an indication of leachate saturation within the area. However, S4, S5, S6, and S7 fall within the recommended WHO safe value for drinking water. A high intake of Copper can cause liver and kidney damage which may eventually lead to death. It also causes stomach aches, dizziness, vomiting, and diarrhea. Figure 8j shows the Iron content of groundwater in the study area with values ranging from 0.11 to 0.32 ppm with an average value of 0.24 ppm. The values obtained at S1, S2, and S3 are generally lower than the WHO recommended safe values for drinking water. The values within S4, S5, S6, and S7 fall within the WHO recommended safe values for drinking water.

Iron concentrations however do not pose a potential health risk as they fall well within the recommended safe value (S4, S5, S6, and S7). Water with high iron concentrations may be discoloured and stain-washed clothing. Figure 8k displays the Manganese concentration values for groundwater ranging from 0.01 to 0.5 ppm with an average value of 0.29 ppm. The values obtained at S1, S2, and S3 fall below the WHO recommended safe value for drinking water. The lower concentrations of

Figure 8: Histogram showing (i) Copper (j) Iron (k) Manganese (l) Phosphate the Phosphate of the Study Area

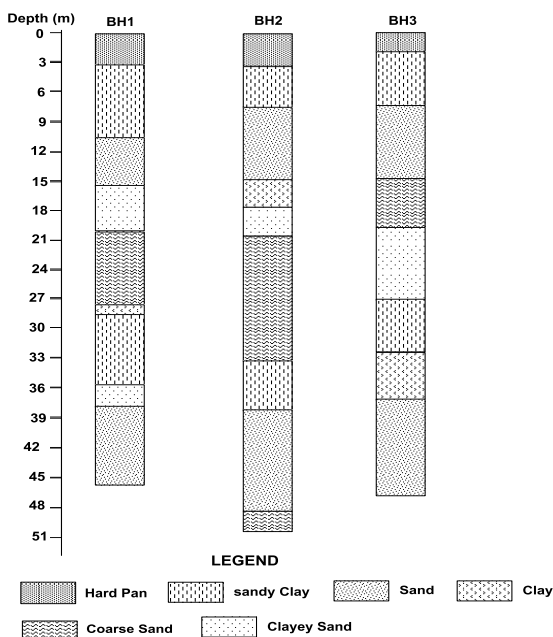
Figure 11: Borehole Data within and outside the landfill

The three-borehole data were analyzed based on the lithological properties to be able to ascertain the causes of migration of the contaminant (Figure 11). The upper 3 m was lateritic which has been contaminated due to the low resistivity observed at the topsoil followed by the sandy clay and sand formations. The sandy formation allows easy migration of the contaminant as a result of high porosity and permeability.

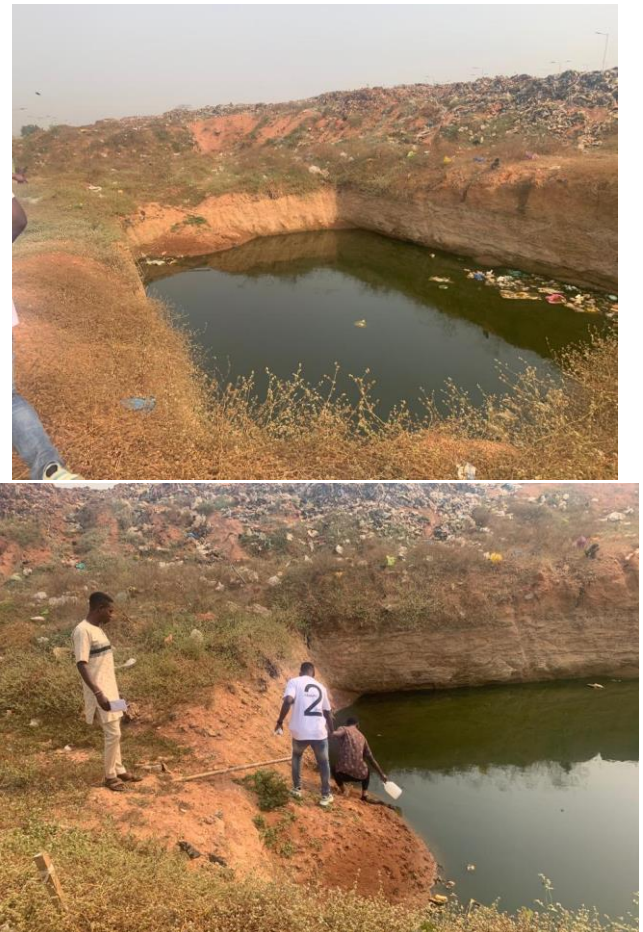
Figure 12: Pictorial View of Leachate Control Points
